CT Numbers:  
Think of a number, double it, add  
20, divide by 4.....

Jane Edwards  
Royal Free Hospital, London

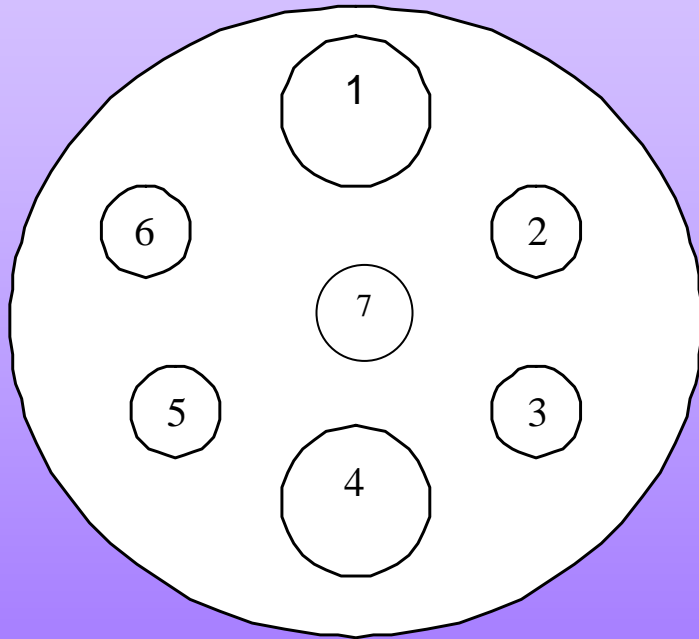
# Philips CT Phantom

1 – Nylon [Calculus/Soft Tissue: 104HU]

2 – Polythene [Fat: -66HU]

3 – Teflon [Bone: 1022HU]

4 – Perspex

5 – Acrylic [Calculus: 141HU]

6 – Lexan [Calculus: 117HU]

7 – Water [-2.3HU]

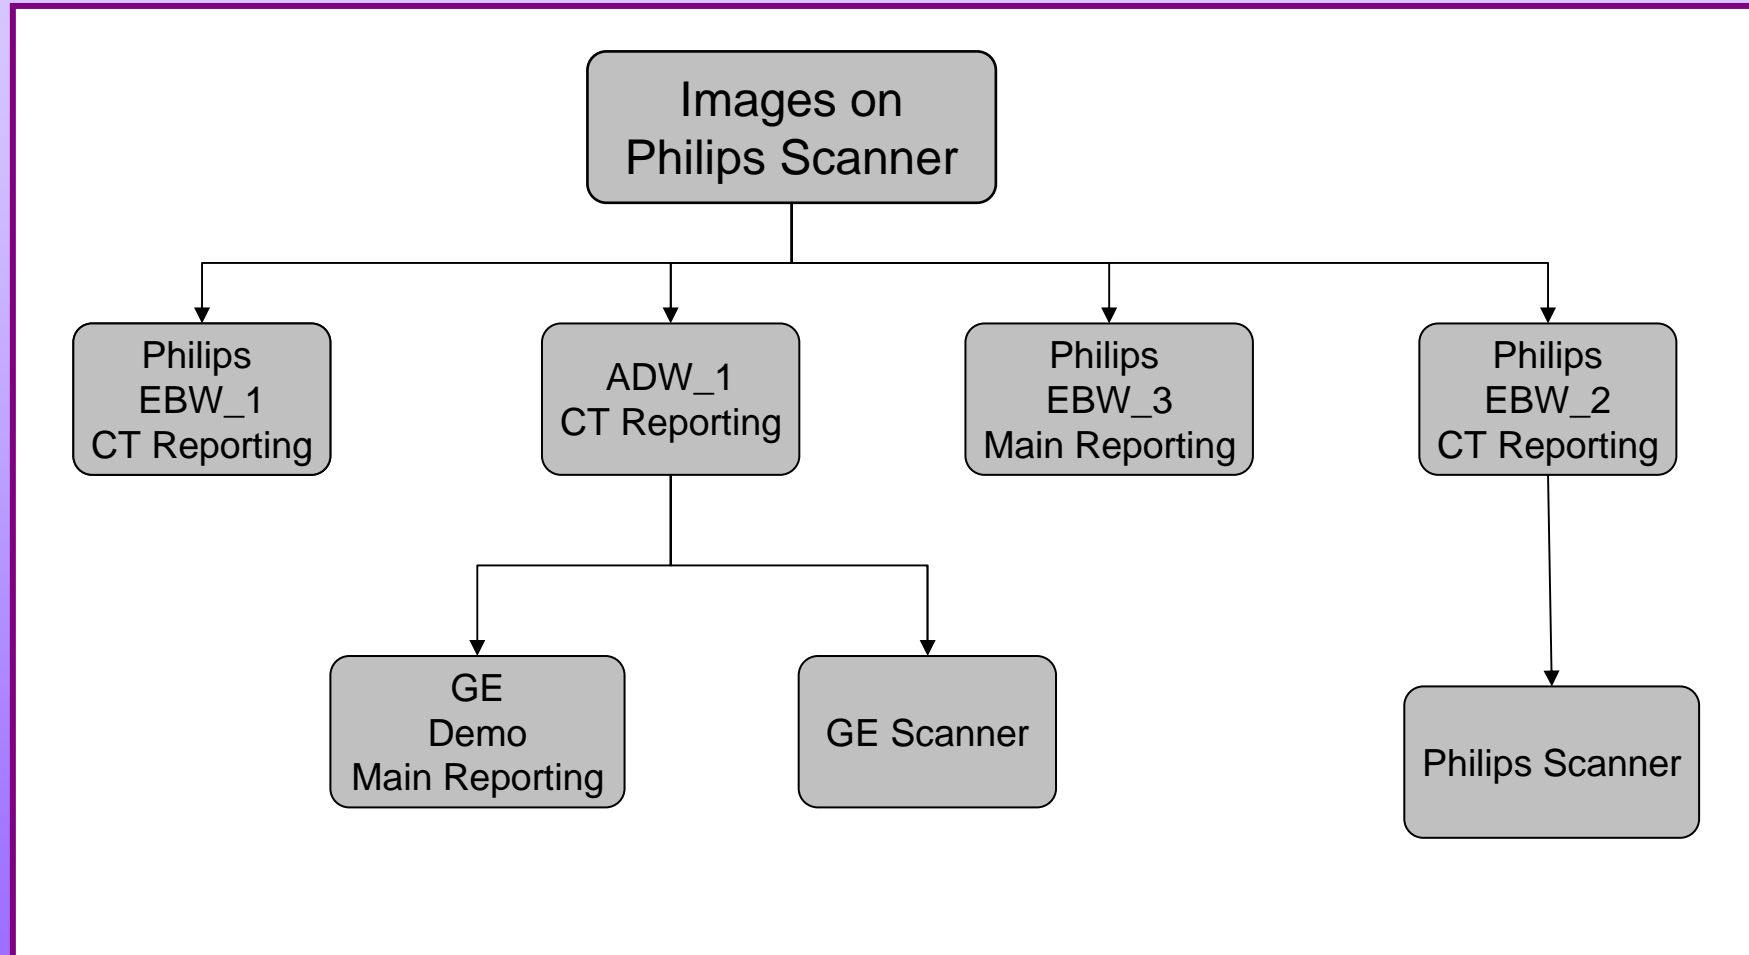
# Philips Scanner

- Philips

kV	120
Set mAs/slice	335
Scan time (s)	1
Collimated slice (mm)	40
Thickness (mm)	16x2.5
Increment	0
FOV (mm)	250
Resolution	Standard
Filter	Std Edge EB

- Analysis of middle image – Image 8

ROI Area (mm <sup>2</sup> )	Material	Lexan	Perspex	Teflon	Polyethylene	Aculon	Water
Philips Scanner	200	Mean CT No	119.9	143.3	1013.1	-66.3	102.2	-1.2
CT Workstation (ADW_1)	202	Mean CT No	120.98	144.45	1014.32	-65.55	103.21	-0.45
EBW_2 Philips WS (CT reporting)	199	Mean CT No	119.9	143.9	1012.4	-65.6	103.1	4
EBW_1 Philips WS (CT reporting)	200	Mean CT No	120.1	143.9	1012.8	-65.5	103	1
EBW_3 Philips WS (Main reporting)	201.9	Mean CT No	119.8	143.8	1012.5	-65.5	103	4
Demo GE WS (Main reporting)	204	Mean CT No	120.88	144.32	1014.36	-65.39	103.23	-0.57
Philips Scanner (re-sent)	200	Mean CT No	118.4	141.8	1010.6	-67.3	101.3	-0.9
GE Scanner	200	Mean CT No	120.85	144.35	1014.36	-65.45	103.04	-0.27
PACS		Mean CT No	122	146	1017	-66	103	-1

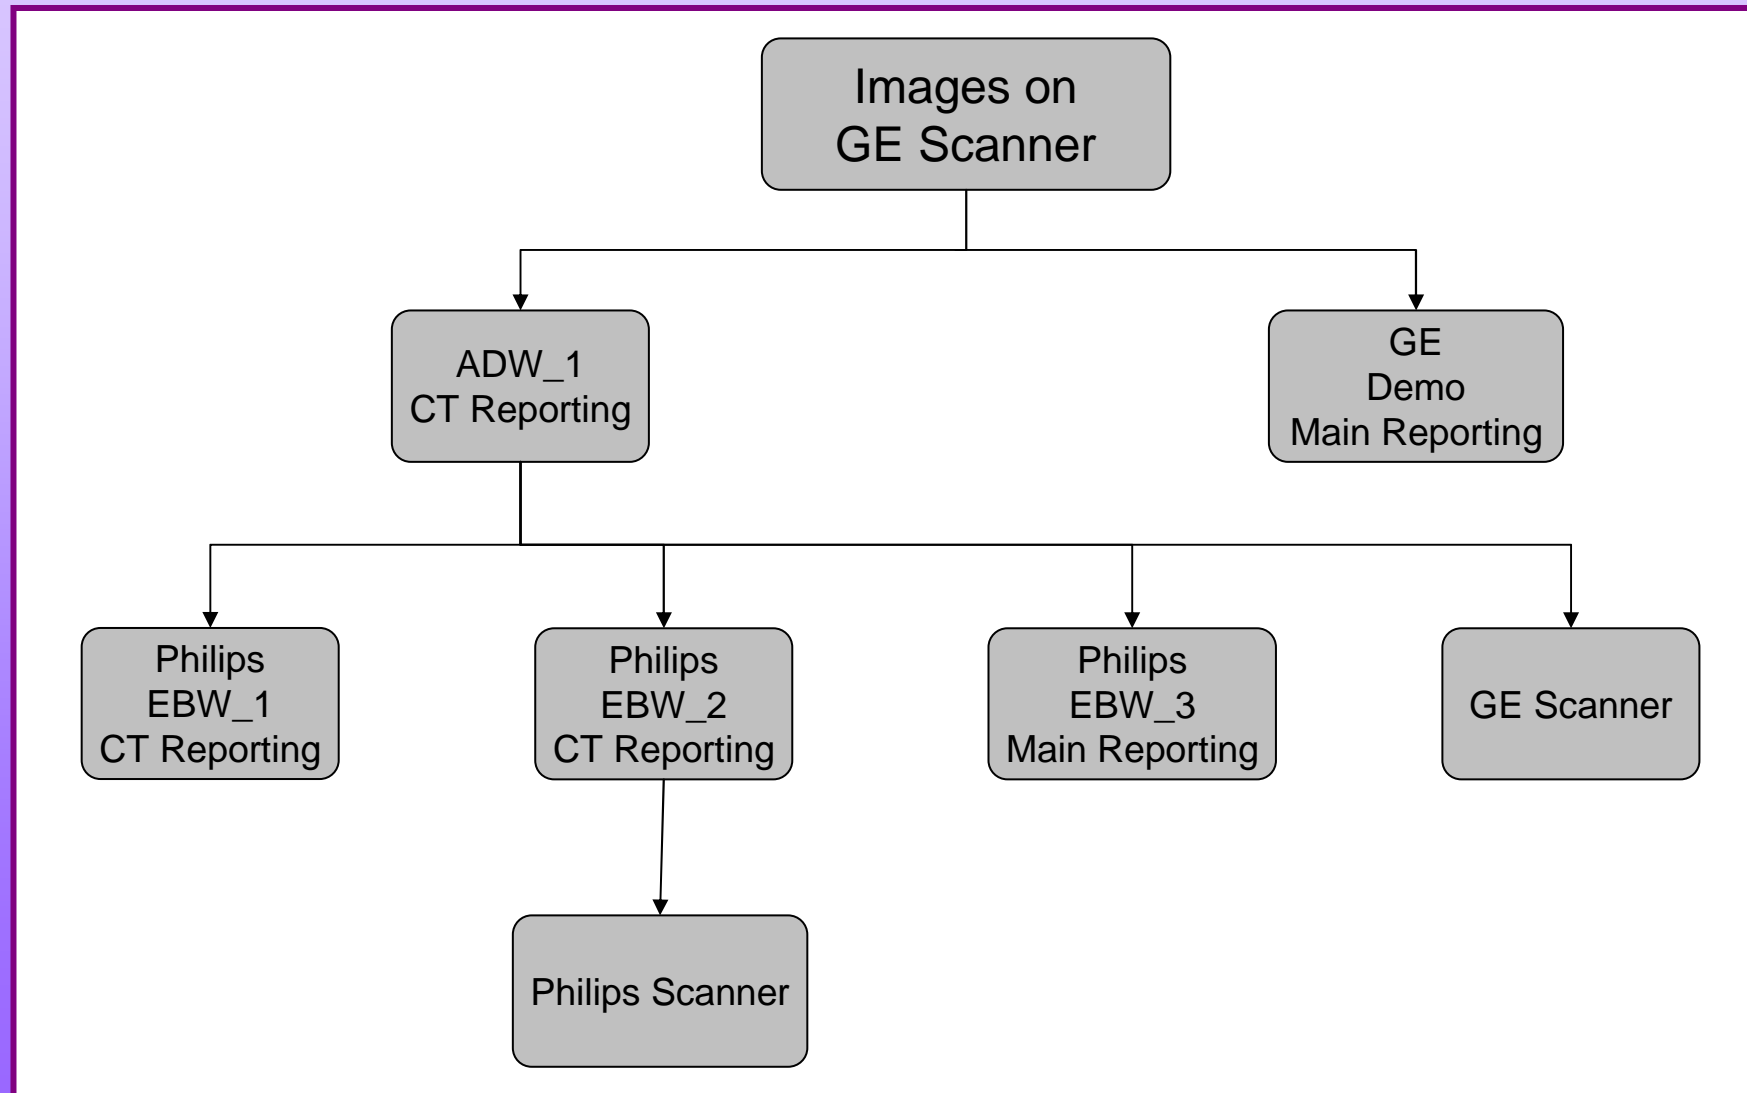
# GE Scanner

- GE

kV	120
Set mAs/slice	335
Scan time (s)	1
Collimated slice (mm)	10
Thickness (mm)	4x2.5
Increment	0
FOV	Small

- Analysis of middle image – Image 2

ROI Area (mm <sup>2</sup> )	Material	Lexan	Perspex	Teflon	Polyethylene	Aculon	Water
GE Scanner	200	Mean CT No	112.19	133.17	915.46	-54.1	101.08	3.42
CT Workstation (ADW_1)	203	Mean CT No	112.2	133.17	916.49	-54.15	101.1	3.5
EBW_2 Philips WS (CT reporting)	201	Mean CT No	135.7	157	940.2	-30.6	124.6	27.9
EBW_1 Philips WS (CT reporting)	201.5	Mean CT No	111.7	132.9	916.4	-54.6	100.6	3.8
EBW_3 Philips WS (Main reporting)	201.9	Mean CT No	135.7	156.9	940.3	-30.6	124.6	27.7
Demo GE WS (Main Reporting)	204	Mean CT No	112.09	133.23	916.39	-54.19	100.98	3.1
Philips Scanner	200	Mean CT No	110.3	132.1	914.9	-56	98.9	2.4
GE Scanner (re-sent)	200	Mean CT No	112.04	133.32	916.63	-54.1	101.14	3.1
PACS		Mean CT No	112.1	133.2	915.4	-54.1	101.1	3.4

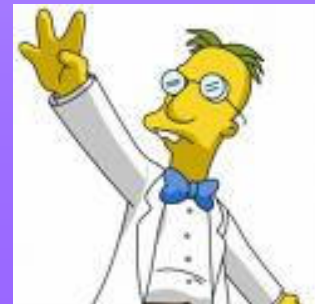
- Philips engineers called in to investigate...
- Showed them the problem and they agreed to investigate;

# The Images....
